DMM International Recall on the Dragon Camming Device in size 6

DMM International has identified a raw material problem that may affect the strength of certain units of the Dragon Cam in size 6 (Product Code A7056A).

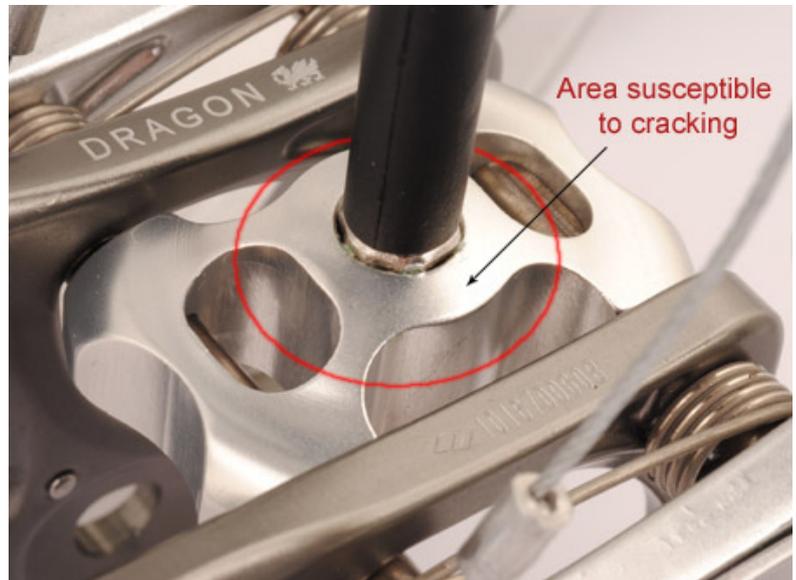
Fig 1 Affected area

The raw material involved is used to make the aluminium axle boss on the Dragon Cam in size 6. DMM International has discovered that the components made out of this defective material can develop cracks and that these cracks can grow and propagate with time. This could cause the units to fail below their rated strength.

However it seems that the most recent delivery of 50mm bar contains sections of bar that have an irregular grain structure and irregular grain boundaries. It is these serious internal grain irregularities that are causing cracks to appear and grow over time. We are currently not certain what proportion of the bar that was delivered is defective, but the raw material, all components made from it and all finished units have been isolated and quarantined. Samples of the bar have gone for independent analysis and we are talking to the mill that supplied the bar about the material.

- The cam stem is then press fitted into the axle boss – at this time and from now on the boss is under stress as the stem is a compression fit.
- If the internal structure of the aluminum material used to make the axle boss contains areas of weakness then it may be unable to resist the expansion forces generated by the stem being in compression and cracks can gradually initiate. These cracks are initially microscopic and not visible, but then over time grow and propagate until they are easily visible.

We have checked stock sitting in the WH and can see very small cracks have started to appear in about 15% of units that are about 1 month old. Units with very small cracks like this are still making over 14kn in destruction testing, however we anticipate that units with larger cracks will break well below their rated strength.

If you own a Dragon Cam 6 with a serial number listed above then you should immediately discontinue all use of this product.

We would also ask that any affected Dragon Cam 6 be returned to the point of purchase or to DMM International so that it can be replaced or credited.
